AQUATIC RESOURCES DELINEATION REPORT

Villa Serena Specific Plan (Tract No. 20245) Project

September 2023 (Revised June 2025)

Villa Serena Specific Plan (Tract No. 20245) Project Upland, California

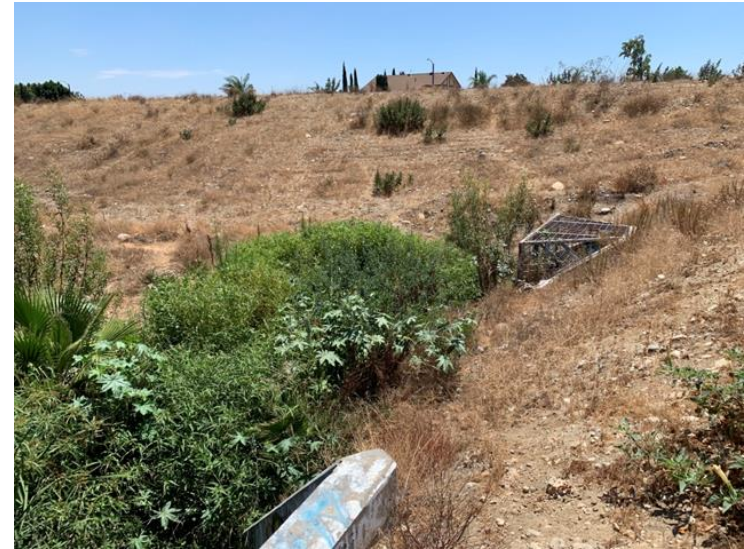
Photo 2: South-facing view of Drainage 1 near the storm drain inlets within the Development Area.

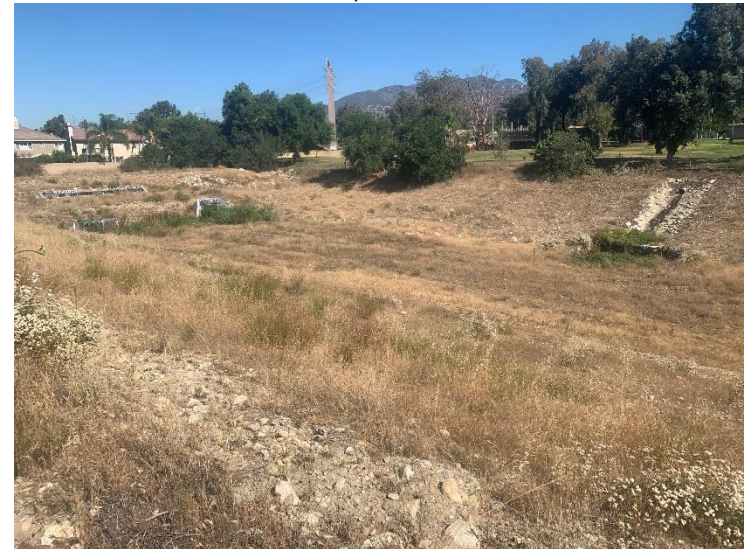
Photo 4: Northwest-facing overview of the Development Area showing Drainages 1 and 2, in the western portion of the Project Site.

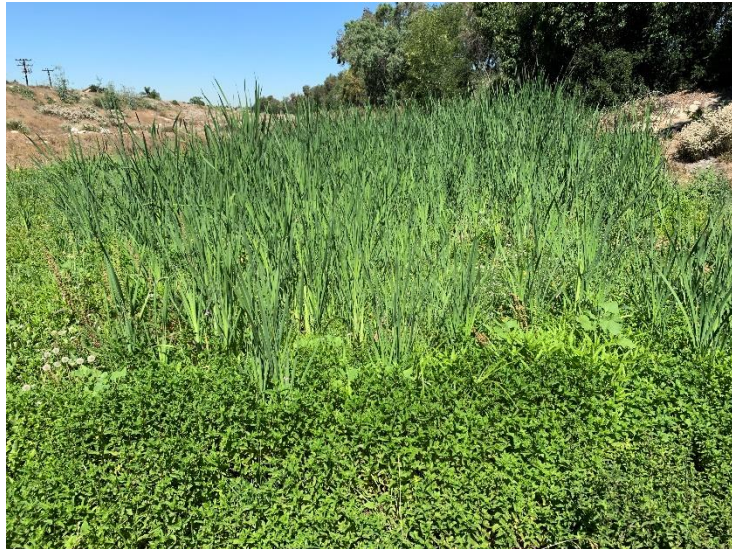
Photo 5: Close-up view of dense cattail marshes within Drainage 3, within the Development Area.

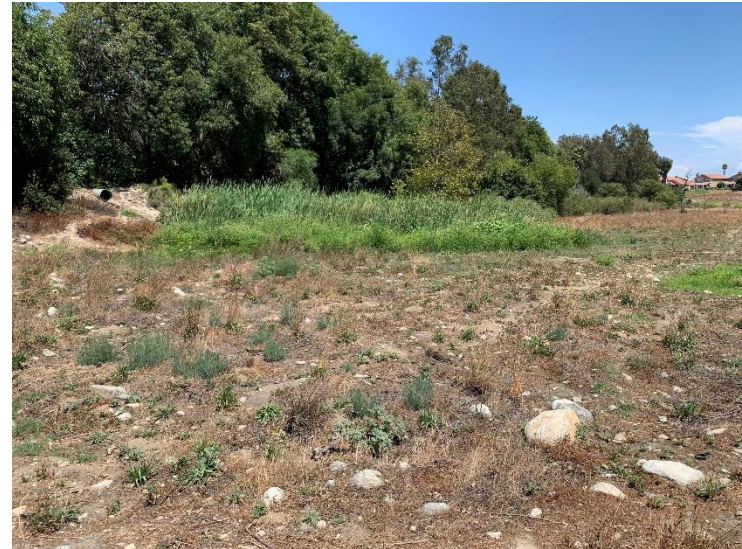
Photo 6: Northeast-facing overview of cattail marshes in Drainage 3, within the Development Area.

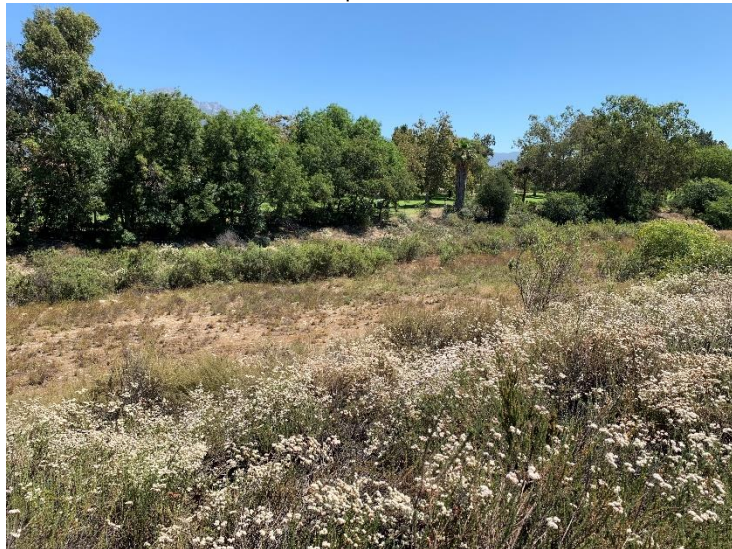
Photo 7: Northeast-facing overview of cattail marshes at one of the side drainages within the Conservation Area.
